Seismic damage to churches: Observations from the 2011 Lorca (Spain) earthquake

Keywords: Lorca earthquake, church damage, masonry, church mechanisms

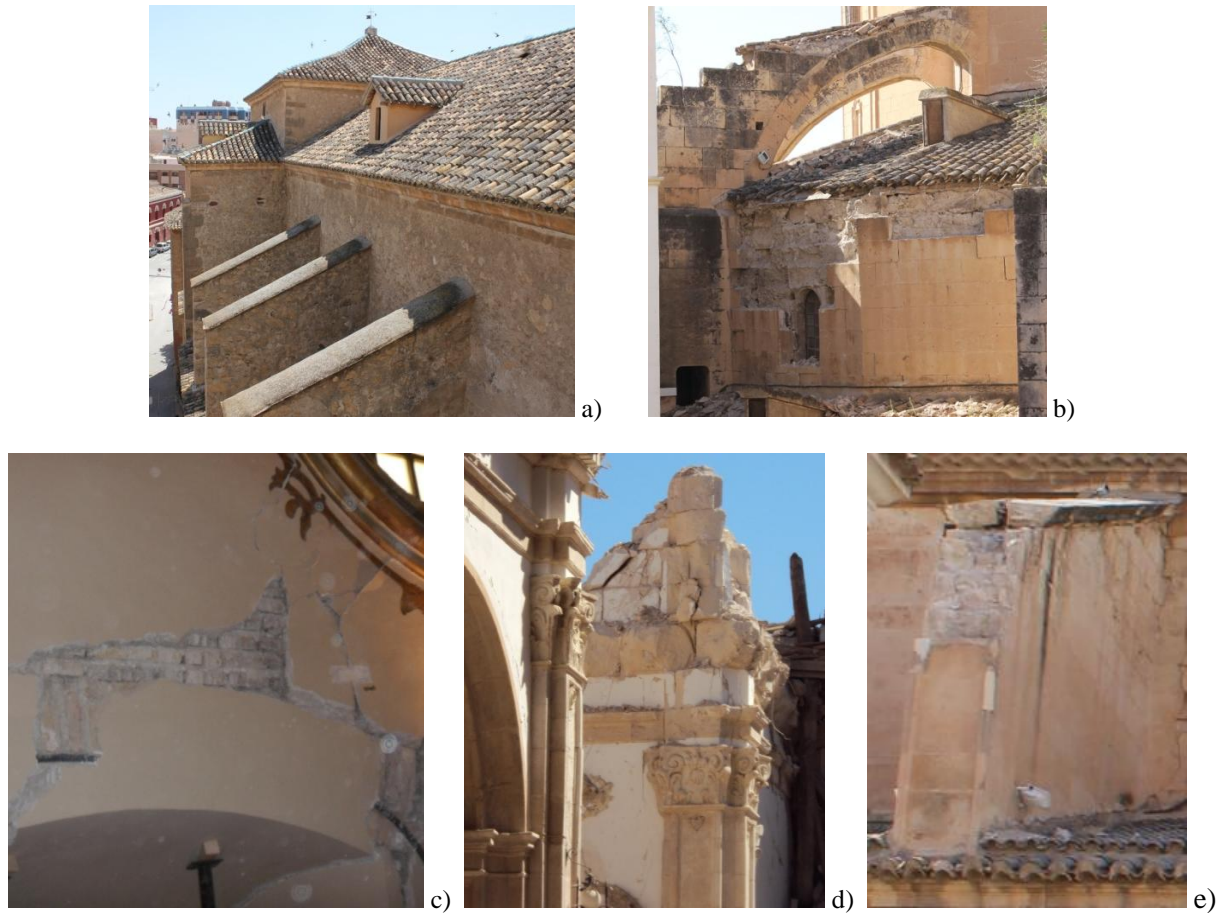
- Masonry type M1: Small and medium size irregular stones with mortar (Fig. 3a);
- Masonry type M2: Two-leaf wall with an outer leaf made of regular cut stone and an internal leaf made of small and medium size irregular stones with mortar (Fig. 3b);
- Masonry type M3: Brickwork (Fig. 3c);
- Masonry type M4: Regular cut stone (Fig. 3d);
- Masonry type M5: Three-leaf wall with regular cut stone leaves of similar thickness (Fig. 3e).

Figure 3. Masonry type M1 at the church of San Francisco (a), M2 at the cathedral of San Patricio (b), M3 at the chapel of N.^a Sr.^a do Rosário (c), M4 at the church of Santiago (d) and M5 at the cathedral of San Patricio (e).

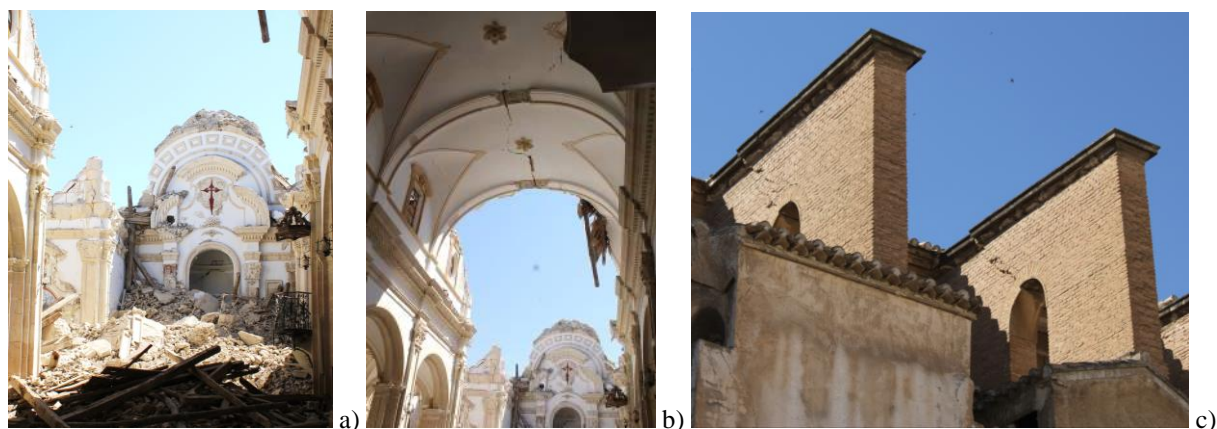
**Figure 4.** Damages to I2 after the collapse of the chancel and of the transept area, including the dome (a) and (b), and extensive cracking of the buttresses (c).

The most severely damaged church was seen to be I2, due to the collapse of the chancel and of the transept area, including the dome (Figs. 4a and 4b), but other significant damages were also observed such as the extensive cracking of the buttresses (Fig. 4c). The tower of this church was also severely affected due to the occurrence of extensive vertical cracking and loss of confinement of the keystones of the belfry arches. At the time of the visit, an emergency confinement with steel ties along the height of the tower was already in place. Since the construction system of church I1 was seen to be similar to that of I2, the level of damage observed in I1 was surprisingly low. The most relevant damages in I1 resulted of decorative elements of the roof and the façade that fell, namely some of them that fell over the roof of the apse. Other damages include displacements of the keystones of the arches of the first level of buttresses, as well as the detachment of the outer leaf of the exterior walls at some parts.

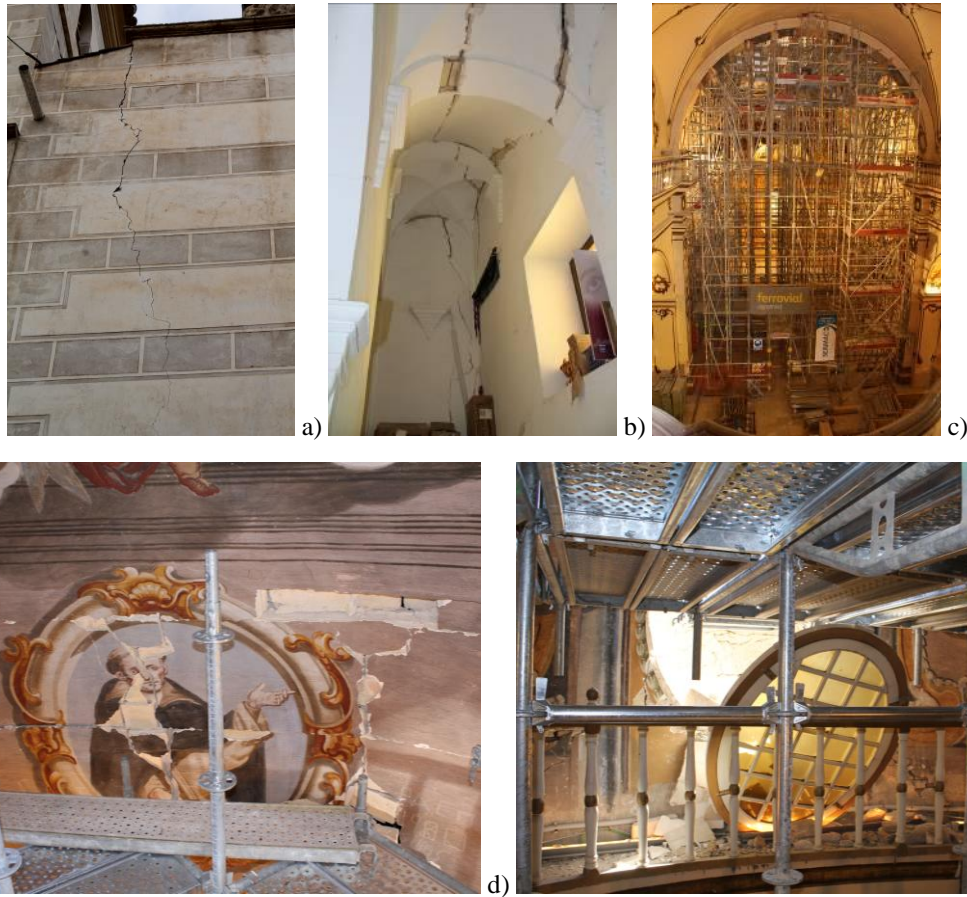
A surprising situation was also observed with respect to the very different damage levels found in churches I3 and I4, which are side-by-side. While church I3 was severely damaged and exhibited extensive cracking in the walls, arches, vaults and in the dome (Fig. 5), church I4 displayed almost no signs of damage, with the exception of some minor cracking on the back wall. Since the masonry type of these two churches is very similar, and assuming that the founding soils are also comparable, the difference between the damage levels of both churches is assumed to be largely caused by the previously referred vertical irregularity of church I3 which differs from the more regular shape of I4. Although the authors believe the damage differences are mainly due to this factor, other aspects can also influence the damage distribution, e.g. the churches might have different foundation types (an aspect for which there was no available information at the time of the visit).

Figure 5. Damages to I3 showing cracking in the façade (a) and in the interior walls and arches (b), emergency shoring of the dome (c), and damages to the dome (d) and (e).

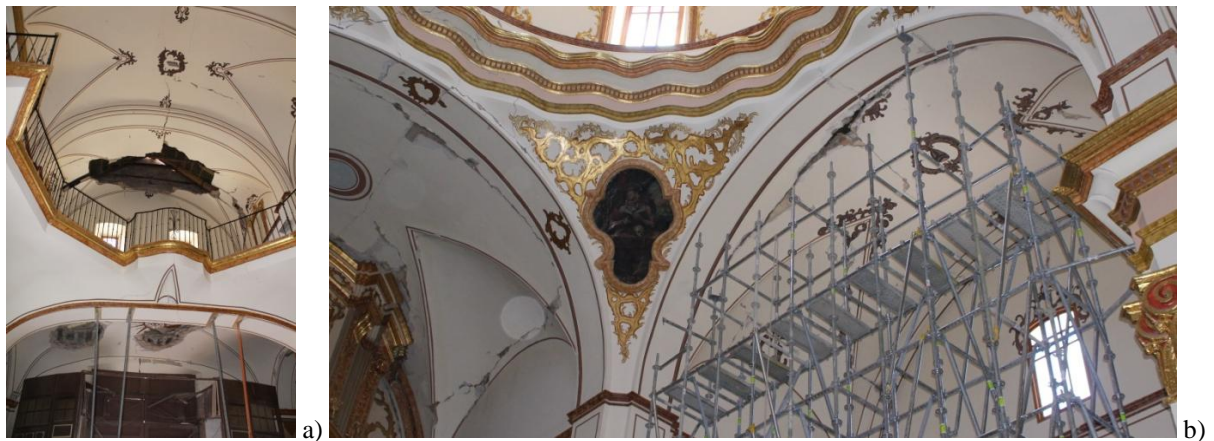
Figure 6. Damages to vaults of I6 from decorative elements that fell (a), detachment of vaults and arches (b).

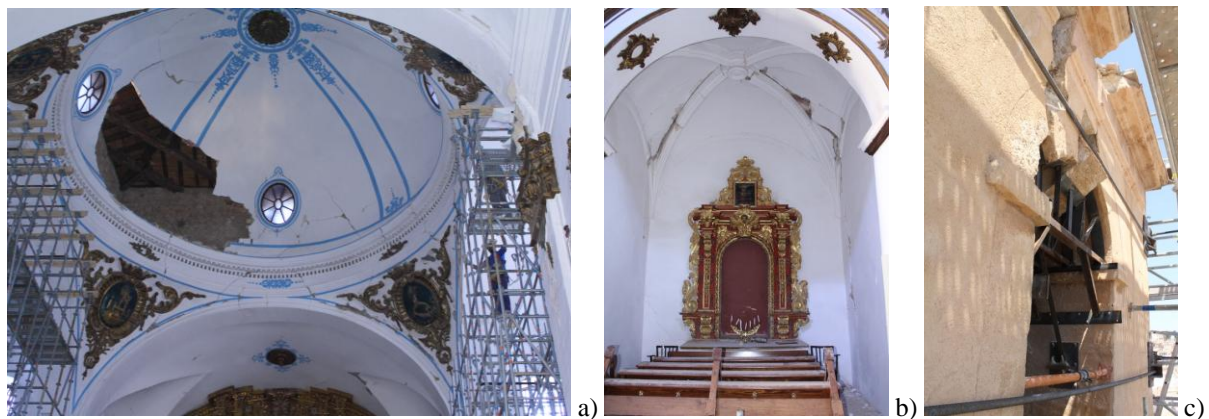
Church I5 was also extensively damaged, particularly the dome, the vaults and the arches of the transept area which were seen to be in a state of near collapse (Figs. 7a and 7b). At the time of the visit, several temporary shoring structures were in place to avoid further damage and the total collapse of these elements. The tower of I5 also showed significant levels of damage, namely deep vertical cracks in the lateral walls and large vertical displacements of the keystones of the belfry arches (Fig. 7c). At the time of the visit, an emergency confinement with steel ties over the height of the tower was also in place, along with shoring structures for the keystones of the belfry arches.

Figure 7. Damages to the dome (a) and lateral chapels (b) of I5, and vertical displacements of the keystone of one of the belfry arches of the tower (c).

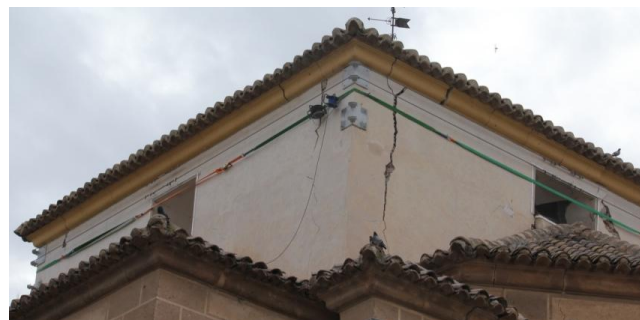
Figure 8. Damage and emergency confinement on the walls that surround the dome of I3.

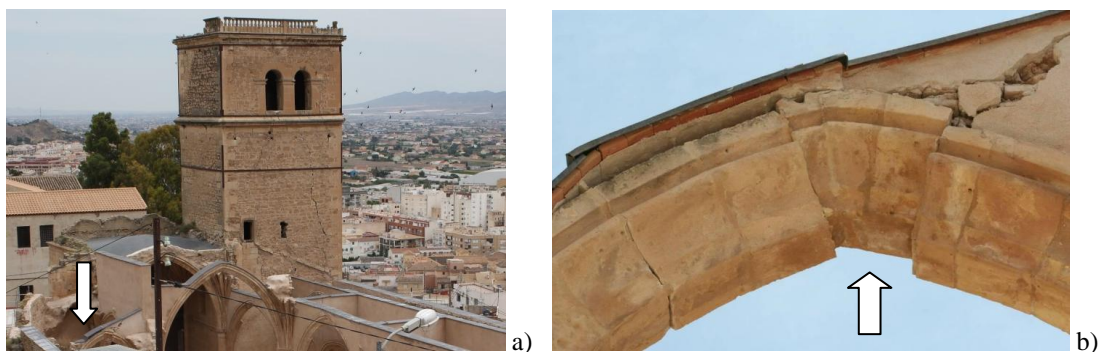
According to Lagomarsino (2012), these components are among the most vulnerable elements of a church and can be significantly damaged even for low intensity earthquakes due to the dynamic amplification of the ground motion as a result of the church characteristics. For example, the bell cell of church I3 was so extensively damaged that authorities decided that it would be best to demolish it. As referred in Table 2, churches I3, I5 and I7 have domes enclosed by lateral walls and topped by a hipped roof. This architectural feature can also be the source of additional damage to the domes if such walls are damaged by extensive cracking that may lead to their detachment, thus making them vulnerable to out-of-plane failure. Although such situation was not observed in churches I5 and I7, the damage on the walls that surround the dome of church I3 (Fig. 8) was seen to be significant and, at the time of the visit, an emergency confinement of such walls with steel ties was also in place. Finally, a reference is made to an uncommon damage found in the ruins of the church of Santa Maria (located north of I1). Although no other damages were apparently caused by the earthquake, the keystone of one of the arches (Fig. 9) seems to have been uplifted by the ground shaking.

Figure 9. Ruins of the church of Santa Maria (a) and damage detail showing the uplift of the keystone of one of the arches due to the earthquake (b).

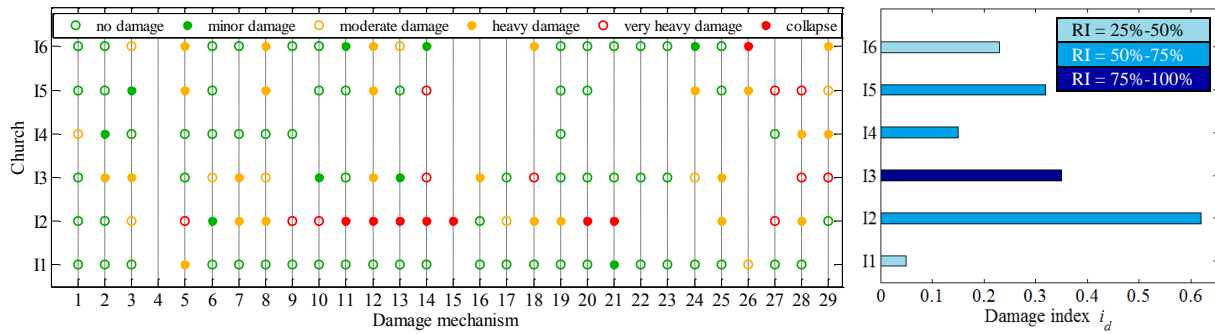
The damage grade and the i_d results obtained for churches I1 to I6 are presented in Fig. 10. The values of i_d are coloured according to their value of RI. The results of Fig. 10 indicate that, with the exception

of I2, the churches underwent only minor/moderate levels of damage in most mechanisms. Hence, the values of i_d are relatively small. Still, Lagomarsino (2012) indicates that when $i_d > 0.3$, churches are found unfit for use. According to Fig. 10, churches I2, I3 and I5 are also found unfit for use, a scenario which agrees with the decisions made by Spanish authorities. Although its i_d value is only 0.23, church I6 was also considered unfit for use by the Spanish authorities. Given the value of RI for I6, its value of i_d (< 0.3) could be seen as a consequence of its lower RI, thus emphasizing the importance of the information involved in RI and the need to consider such issue in a future review of the procedure.

Figure 10. Damage grade of each mechanism and global damage index i_d for churches I1 to I6.
